*Fortuna Silver Mines Inc.*

**Drill Hole Intercepts:  
Trinidad Footwall structures  
Longitudinal Section (Looking West)  
San Jose Mine, Oaxaca, Mx**

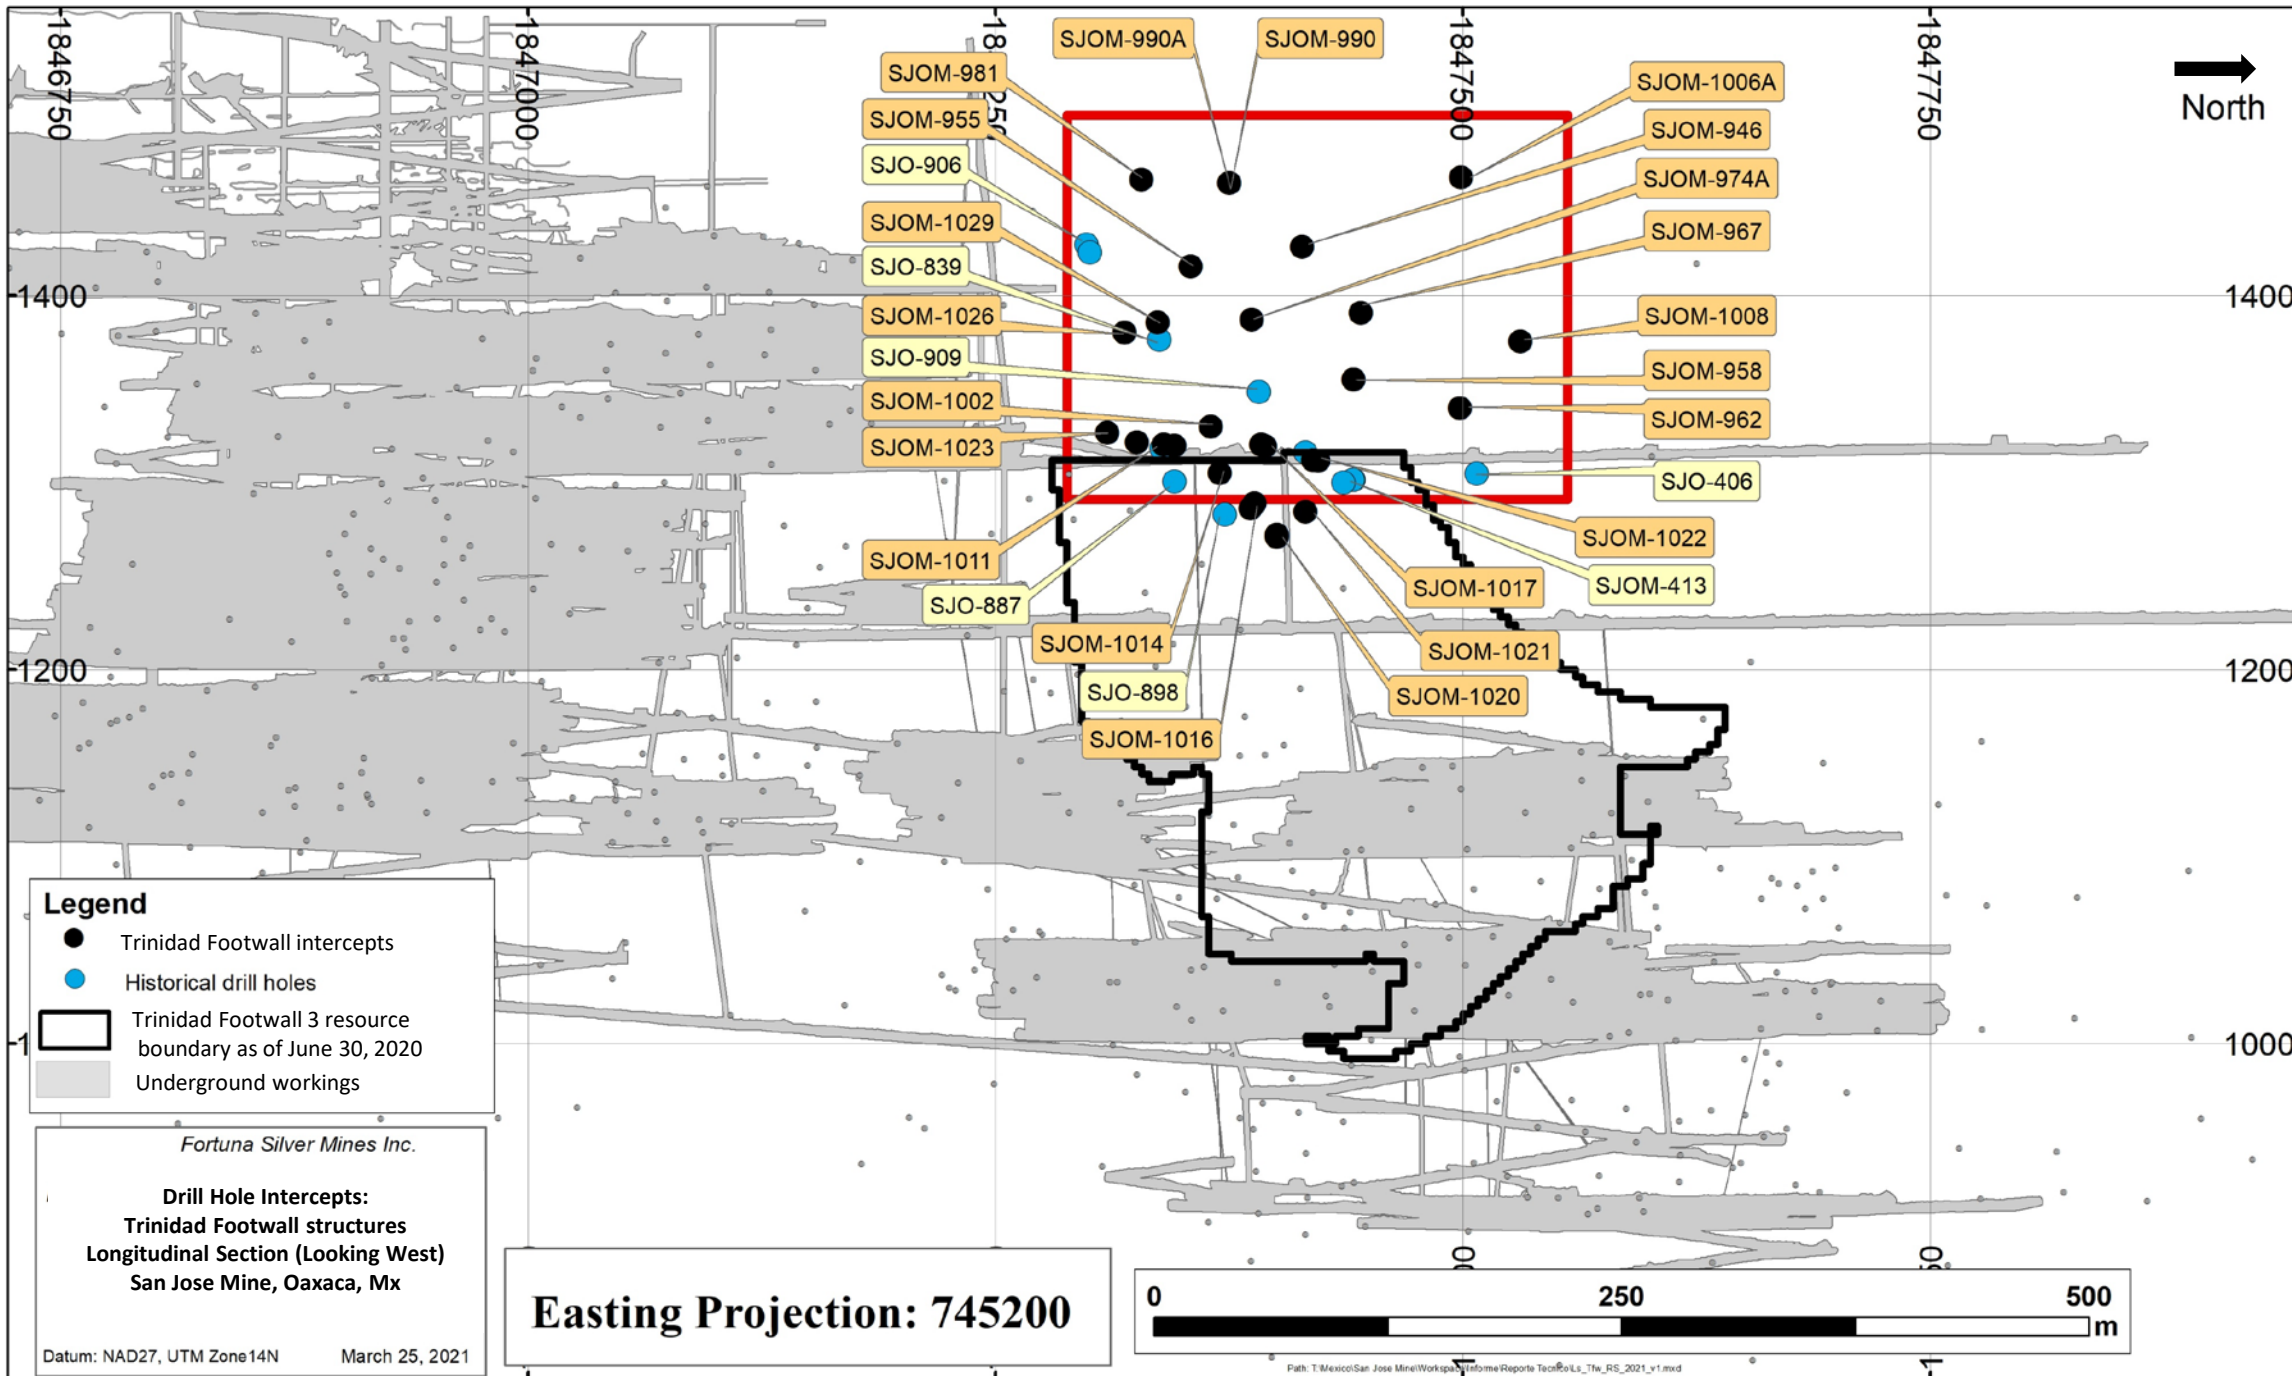
- Trinidad Footwall intercepts
- Historical drill holes
- Trinidad Footwall 3 resource boundary as of June 30, 2020
- Underground workings

**Easting Projection: 745200**
